## *BrakeTech USA*

August 2014

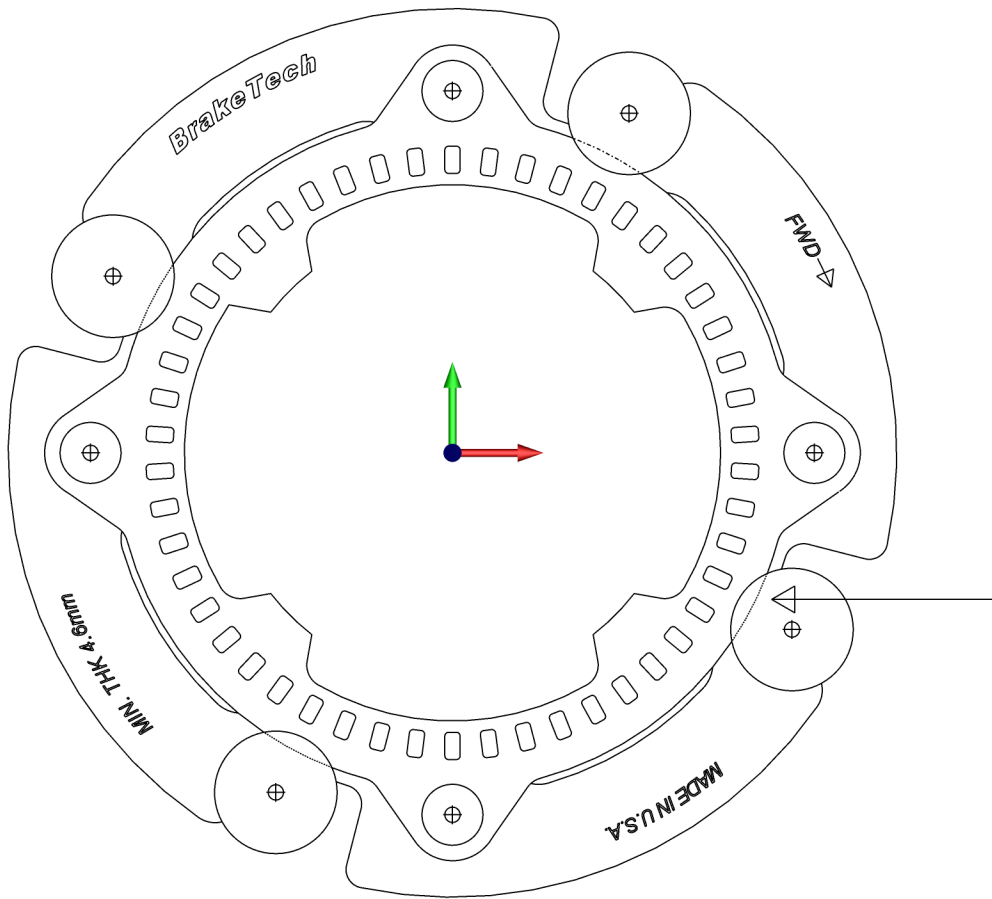
Diagram here shows the light modification of the OE ABS Sensor Ring required for proper fitment of the AXIS series full-floaters

In the case of the S1000RR, ZX10R, etc. the rolled over lip of the OE sensor ring must be ground off to flush to allow it to properly seat on the carrier. Same applies to the small amount of material adjacent to the bobbin flangeheads (shown as dotted lines)

This fitment modification is representative for nearly all models utilizing ABS sensor rings
